## Introduction

## Existing Conditions Survey

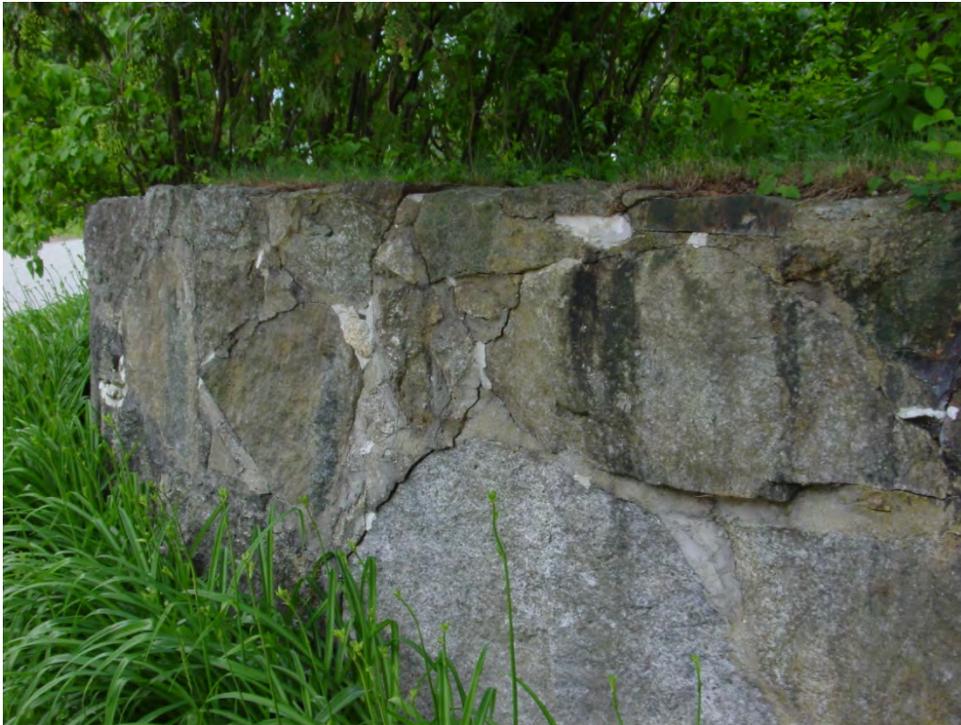
The curved stone retaining walls towards the back of the meetinghouse are in reasonably good condition. However, the easterly side of the retaining walls is beginning to bow-out due to the increasing pressure of the root systems from the cedar bushes (now trees) planted behind them.

It would appear that over the years, several repairs have been made with various types/colors of mortar.

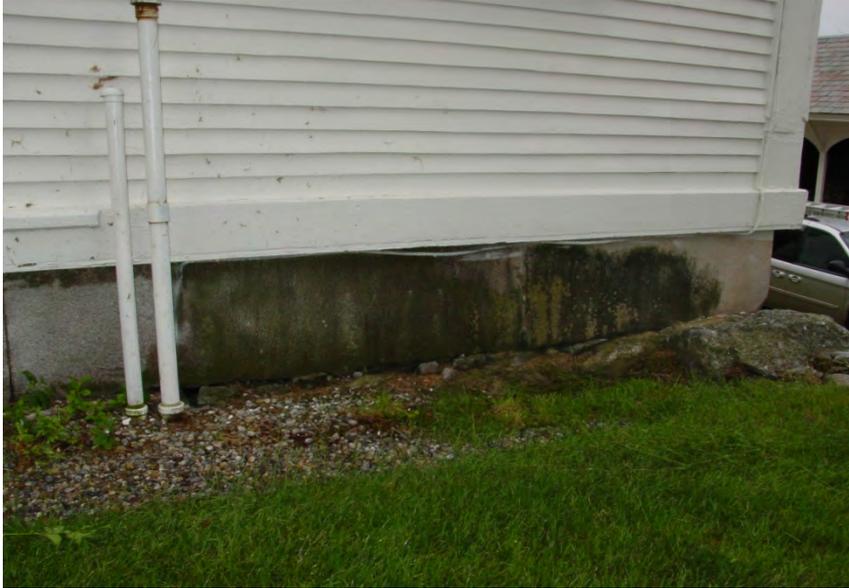
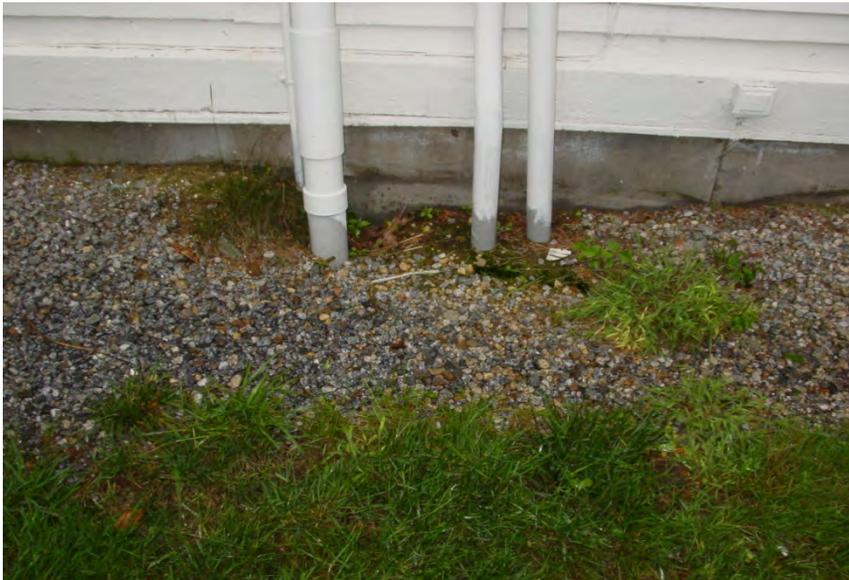
Areas along the east elevation with water infiltration problems

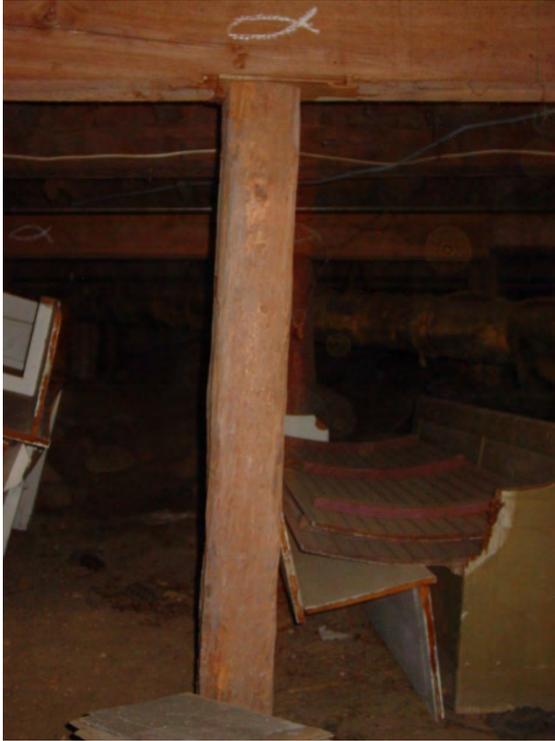
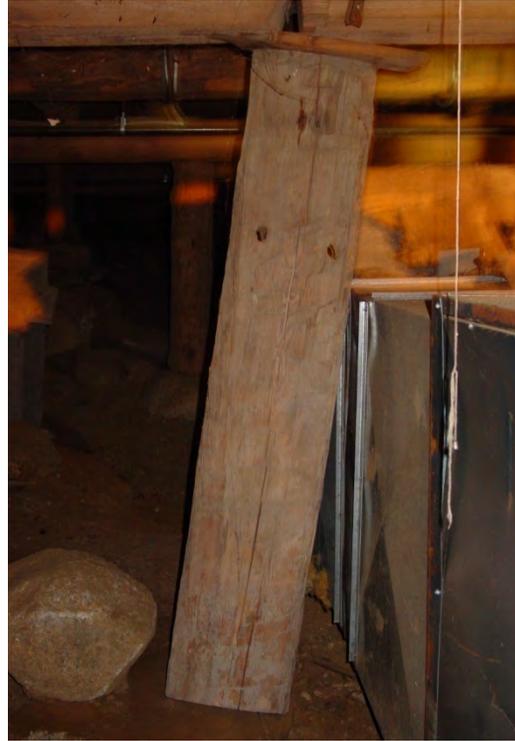
While the majority of the posts and the stone pilings within the cellar appear to be in reasonably good condition, there are some that should be adjusted and straightened.

Listing posts in the cellar

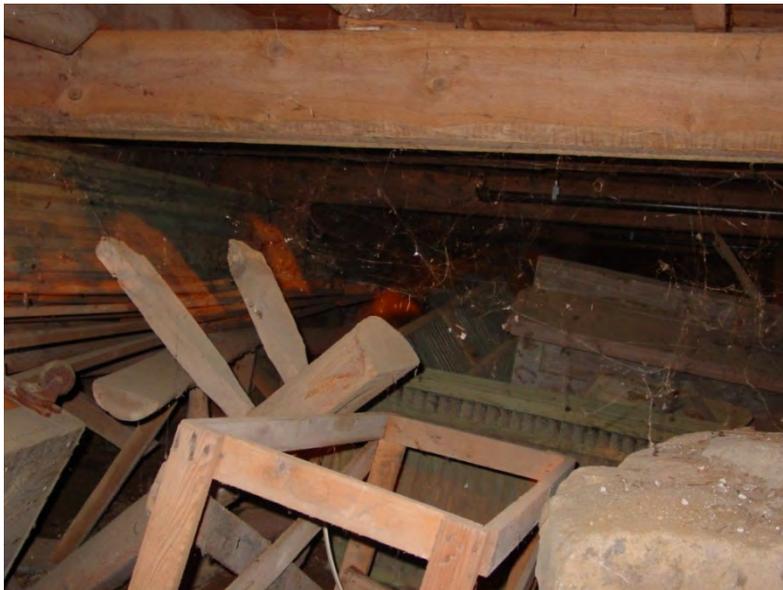
A typical amount of debris has accumulated in the cellar. There are several remnants of historical benches, pews and building parts, including exterior blinds (shutters), doors and finials that are currently in contact with the ground (dirt).

Examples of the stuff currently stored in the cellar

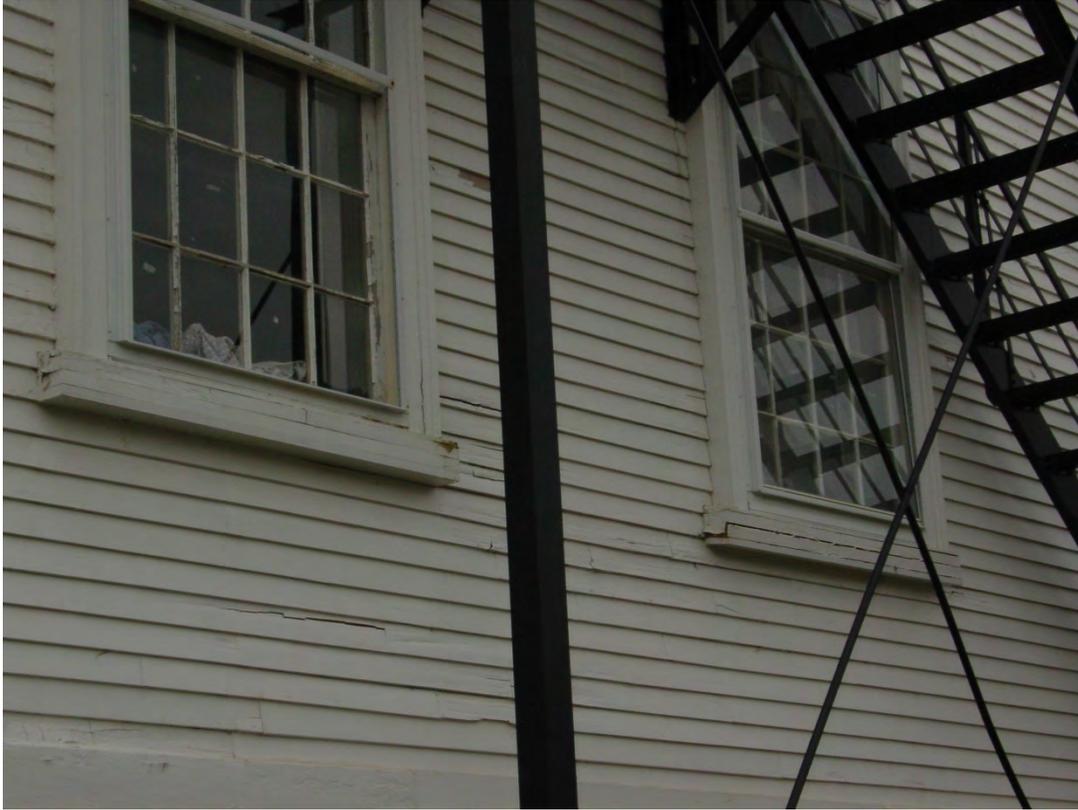
These sills were replaced with laminated wood that has now failed

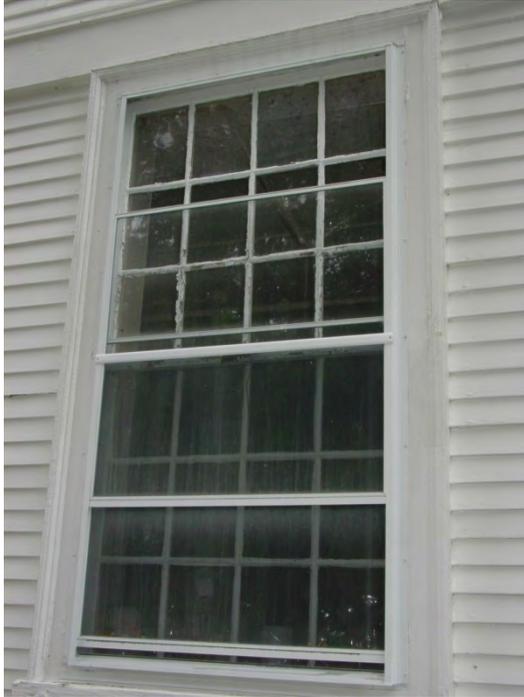
When the storm window is not fully closed, it hastens the deterioration of the primary sash.

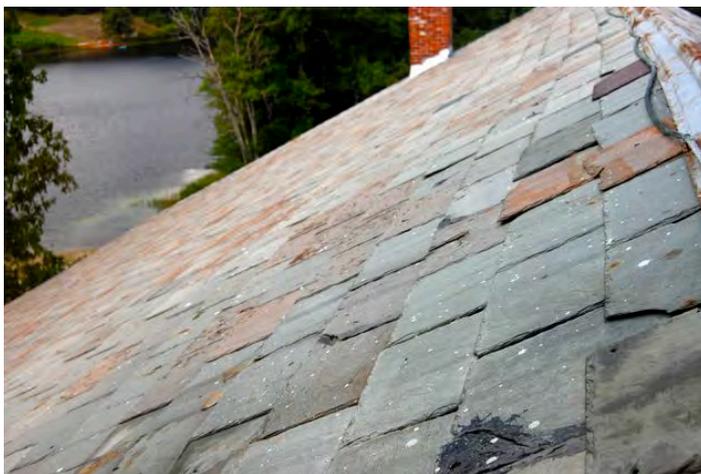
West roof slope, showing slate conditions prior to Winter 2010-2011

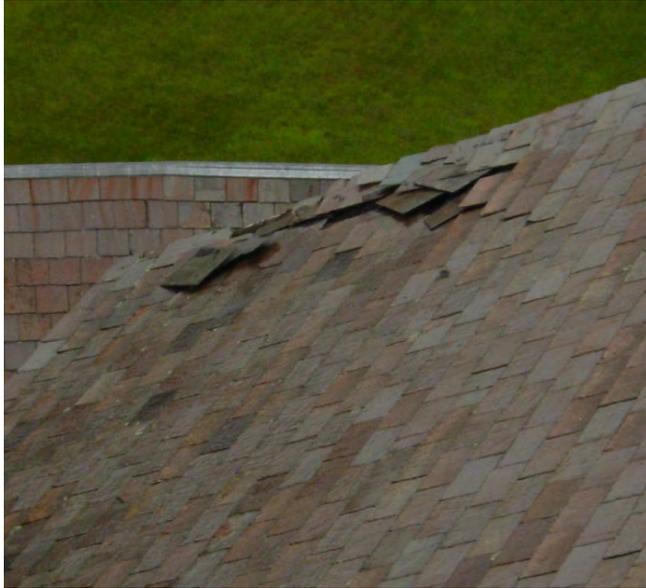
The same slope, showing its condition after Winter 2010-2011

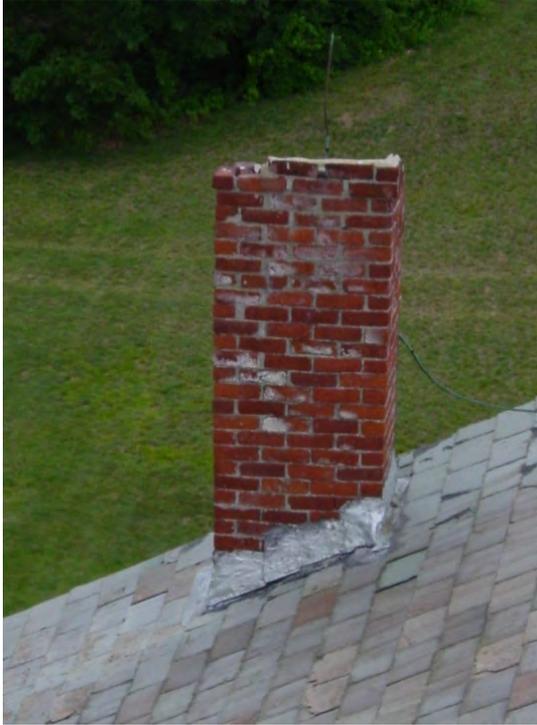
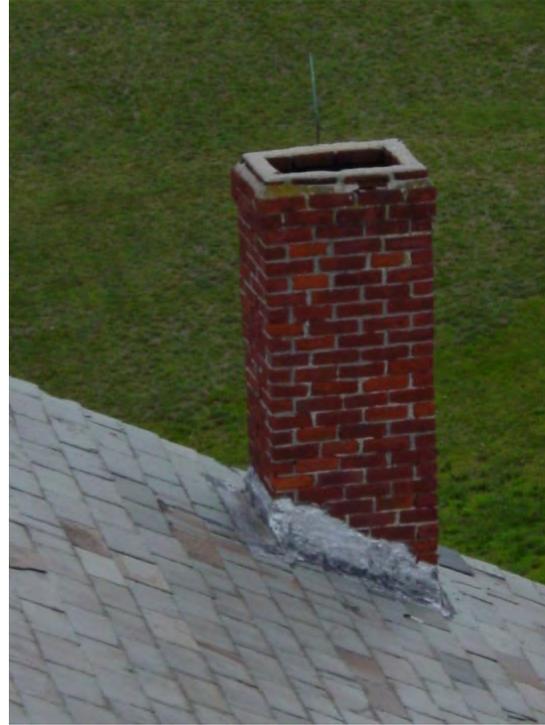
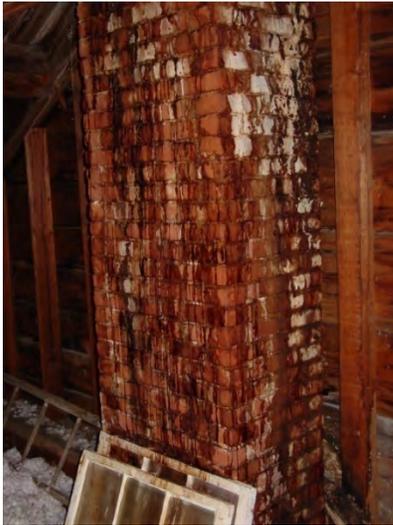
West chimney, between attic floor and roof ridge, showing creosote seepage and missing mortar.

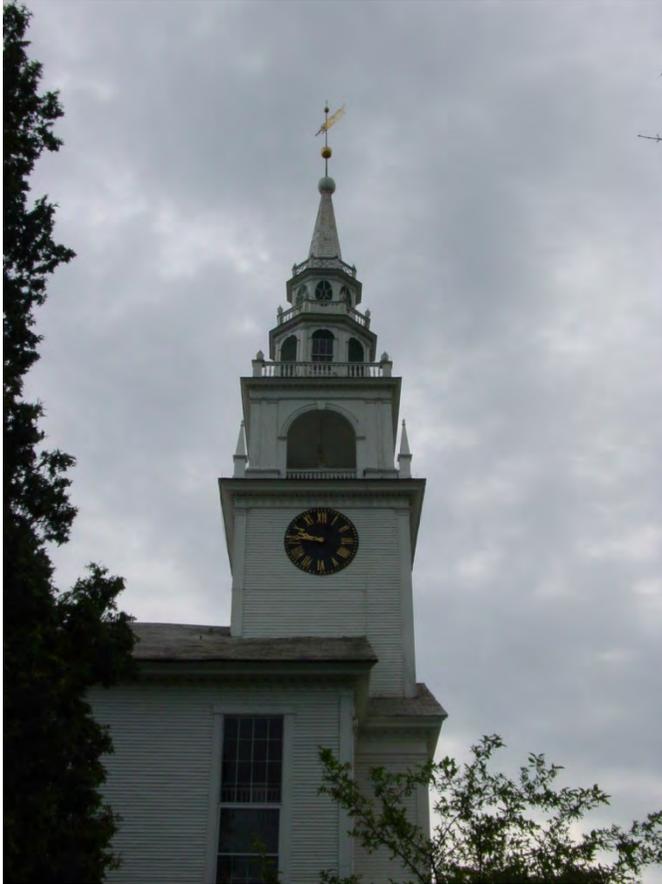
Note the backward lean of the clock tower and belfry.

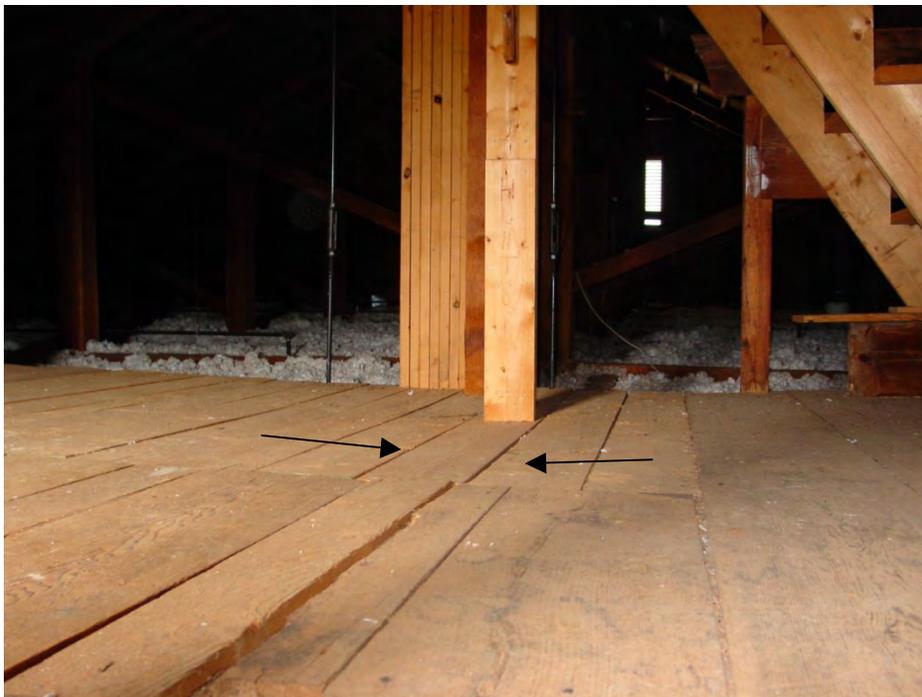
The arrows show the sag towards the center of the attic floor

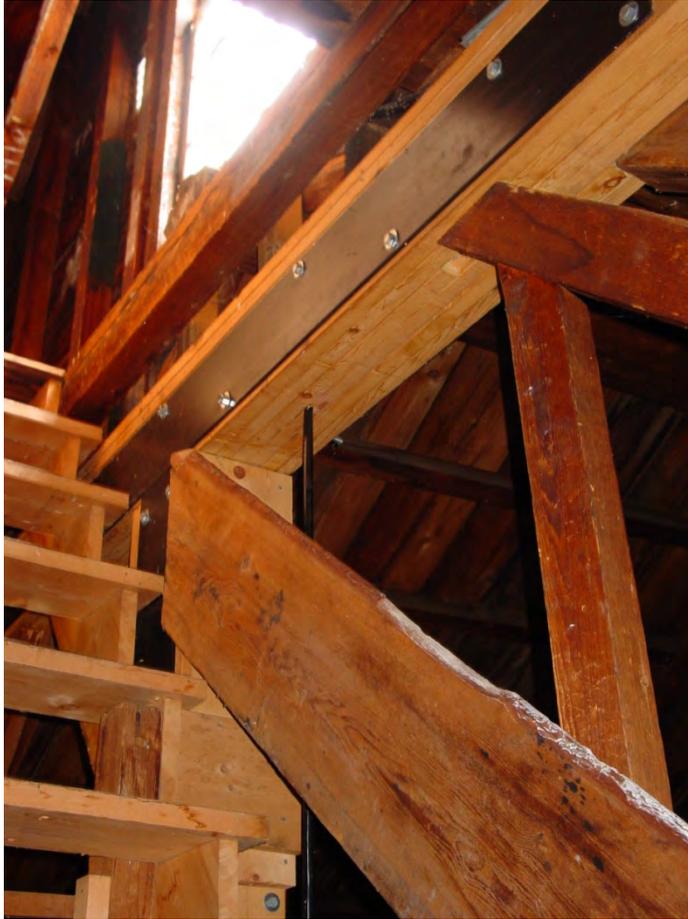
View taken of steps leading to clock mechanism, showing additional framing members added to attempt to address the sag in the ceiling of the sanctuary below.

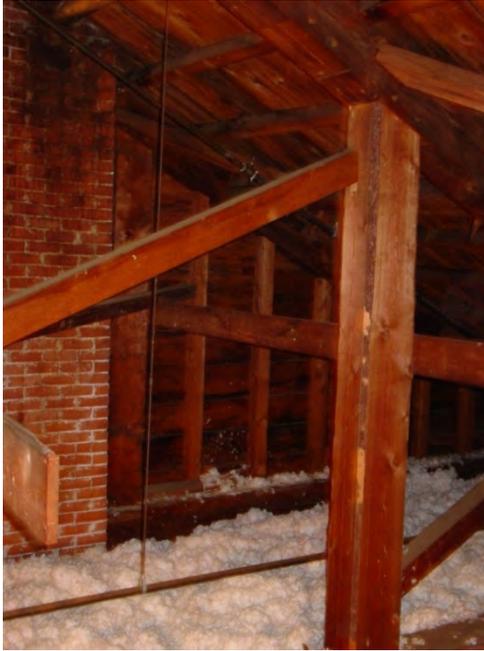
Existing insulation in the attic is limited to the floor

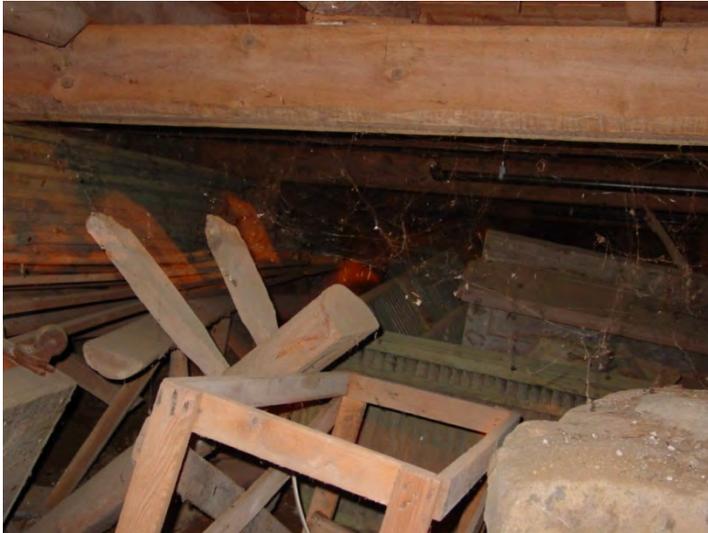
Sample of the miscellaneous stuff that needs to be sorted and disposed of or properly stored

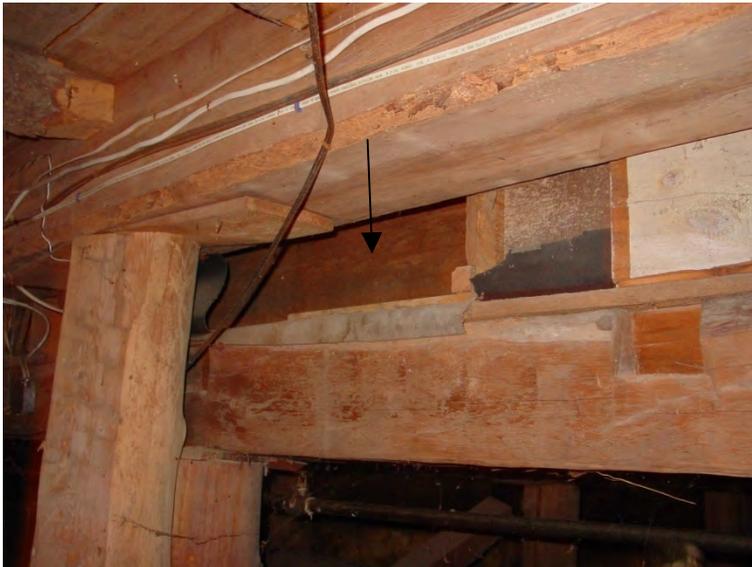
The arrow in the photograph above shows the open space beneath the bench seats that opens directly into the cellar and should be insulated.
