## Introduction

## Existing Conditions Survey

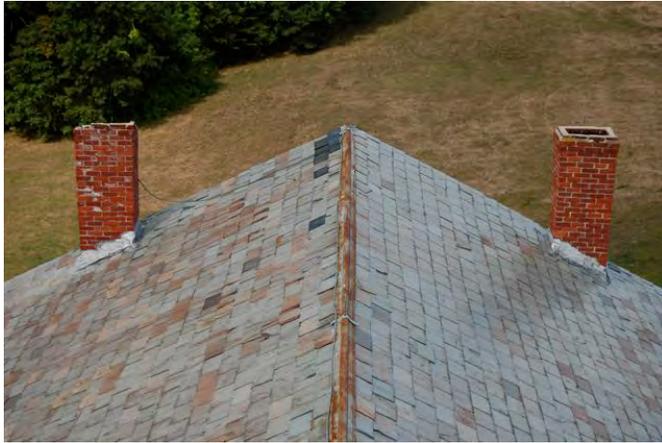
The rear chimneys were built in 1878 with corbeled caps, perhaps damaged by and removed following the 1938 Hurricane. (They were gone by 1947.)

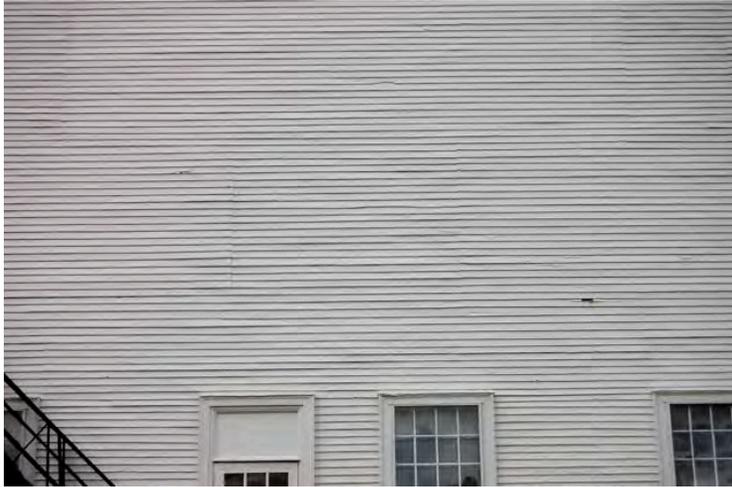
On the rear of the building, however, there are obvious cuts where the second story windows and even the center pulpit window, which was between the two stories, were located. This is important physical documentation.

The shadow line of the pulpit window directly above the door and window to the right is readily apparent. It was removed in 1851. Note the cuts to either side, which were second story windows that were directly above those on the first.

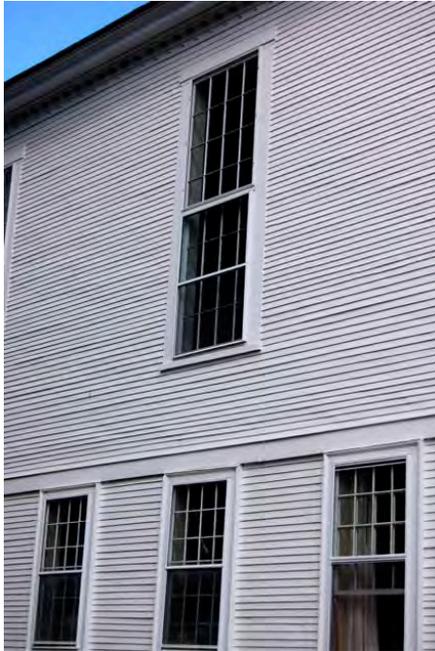
When the building was renovated in 1851 and first floor windows dropped, the town obscured evidence of the cut by installing a horizontal trim band immediately above the window heads.

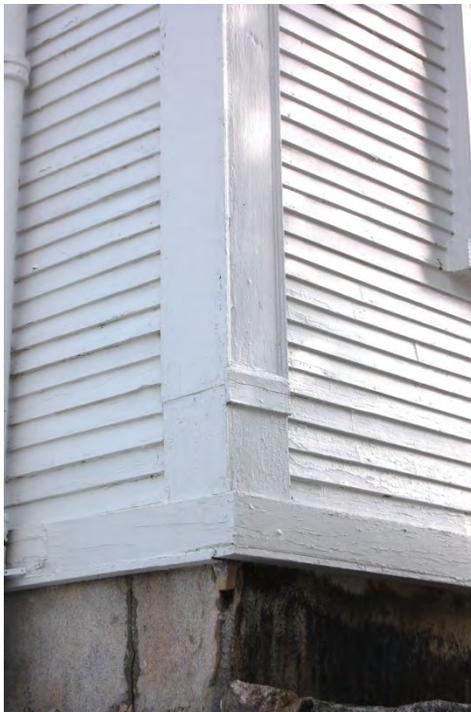
Near the foot of every cornerboard and pilaster, as well as on the pilasters and frame of the front entrance doorways, there is a horizontal cut at a consistent height from the bottom trim board. A sure explanation of this cut cannot be made, but it could have been tied to sill replacement during the 1851 move, or it could reflect the available length of boards and this was a neat way to work with shorter boards.

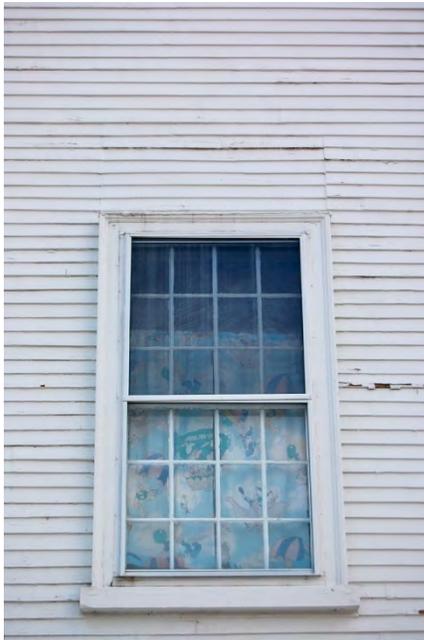
All of the 1820 windows along the side elevations and rear were dropped approximately 18" in 1851. Though the cuts were carefully concealed on the side elevations with wooden trim, in the less visible rear, no such care was taken. Note the cut line above this window.

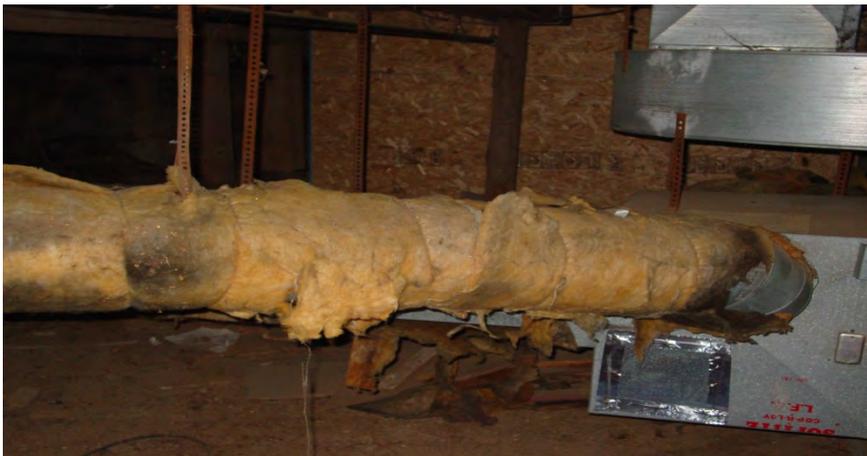
The current furnace insulation covering the ductwork is inefficient, in poor condition and is an attraction for animals to nest.

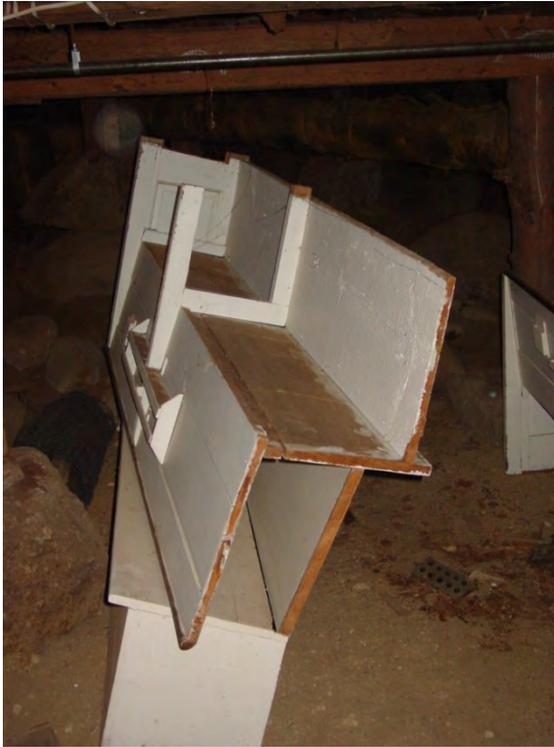
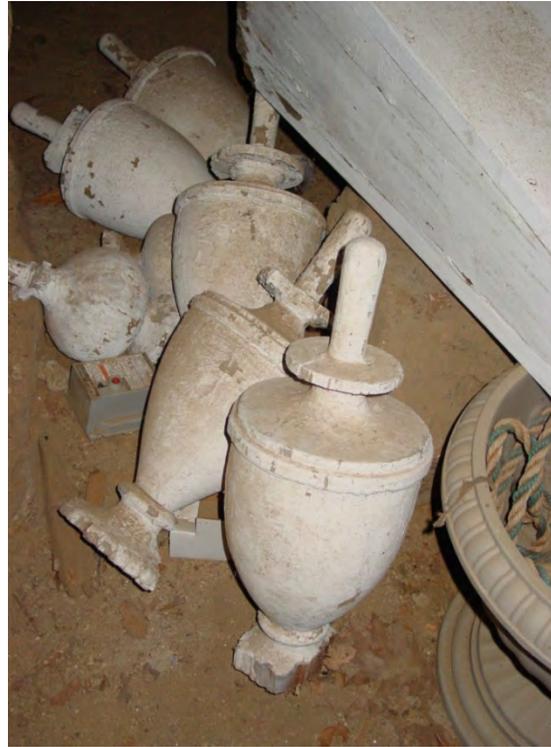
A typical amount of debris has accumulated in the cellar. There are several remnants of historical benches, pews and building parts, including exterior blinds (shutters), doors and finials that are currently in contact with the ground (dirt).

Examples of the stuff currently stored in the cellar

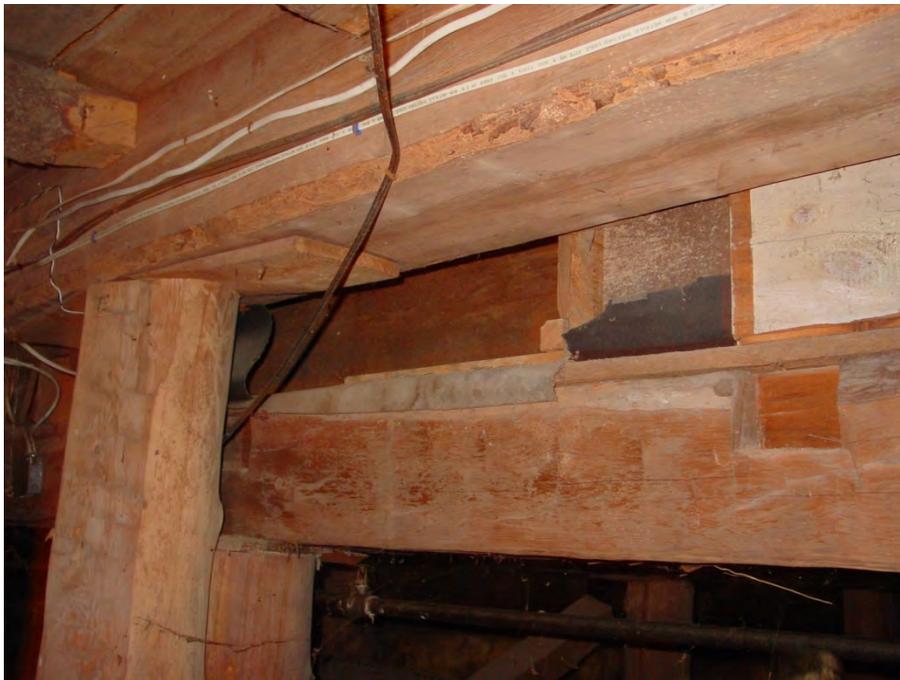
original carriers nor the later carriers are connected to the exterior framing of the structure at all. Instead, additional posts were added to support the weight of the floor system. The lowered framing is at the level of the granite foundation instead of being tied to the original sills located on top of the granite.

To a certain extent, these lowered timbers are floating within the granite foundation in this area of the meetinghouse with only the bench seating and non-structural elements holding the framing in place. This would account for the greater number of supporting posts placed under the timbers.

In the vast majority of situations, this arrangement would not have worked. However, in this situation, due to good soil conditions and good drainage, this unusual framing approach appears to be working adequately.

Lowered framing under the partition separating the vestibule from the former Town Hall.

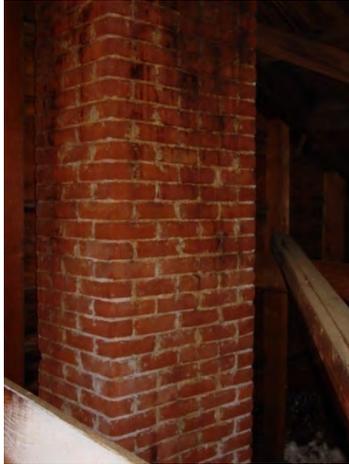
The chimney on the east slope appears to be in better condition and may only have to be repaired to just below the roof line.

East chimney, shown between attic floor and roof ridge

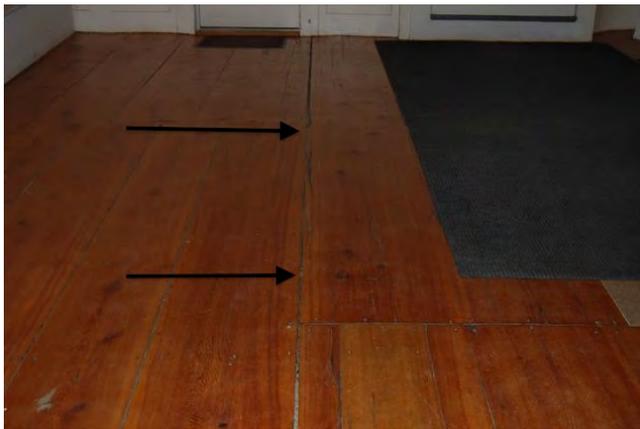
In general, the wood framing of the Meetinghouse (exclusive of framing above the belfry, reviewed elsewhere in this report) is in good condition. However, during the renovations undertaken after the building was moved in 1851, the partition wall between the front vestibule and the Town Hall (downstairs) was moved back to the north to the existing location. The original location of this partition is readily detectable by the “hump” in the floor of the vestibule. The moving of the partition caused partial failures in the tower.

The crack in the floor boards in the vestibule, shown in the middle of the photograph, follows the line of the original partition wall.

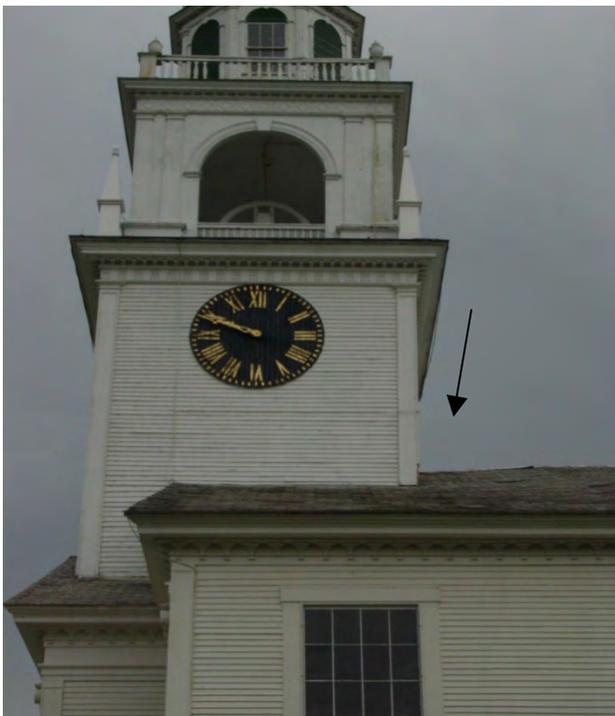
When the previously described partition between the vestibule and Town Hall space were moved back toward the north in 1851 and has since remained, and the support timbers in the balcony were moved and/or modified, this caused the back section of the tower to lean beyond what is the norm for towers in most meetinghouses. This lean, in turn, has caused the sag in the roof ridge pole, since it is attached to the leaning tower.

Arrow points to the roof sag behind the tower

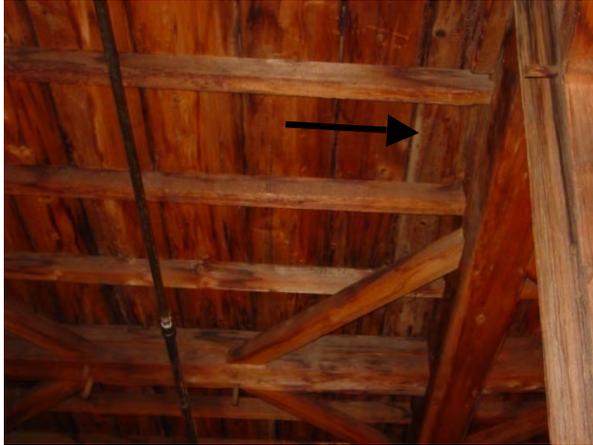
Looking west at the roof framing just behind the tower, showing the sagging rafter.

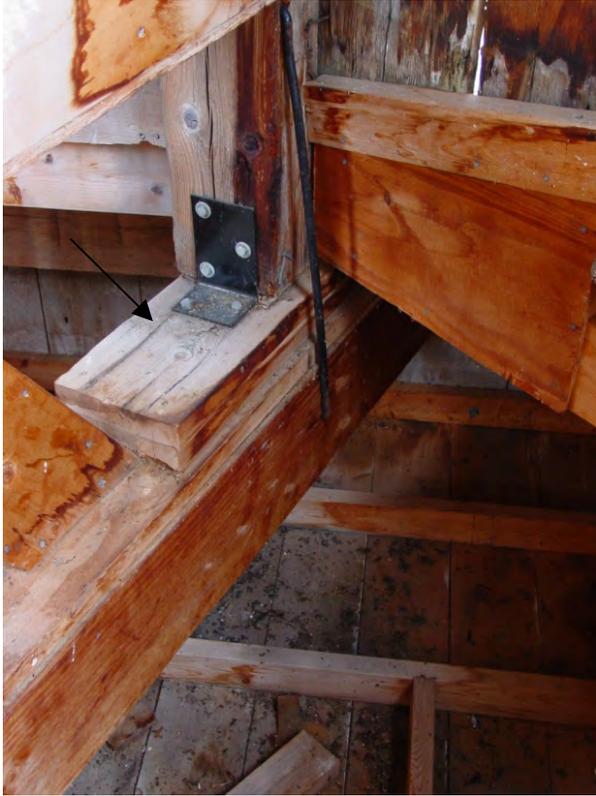
No additional supporting framing was added underneath to help transfer or spread the load to the ground level. The end result is that the clock tower and belfry are still considerably out of plumb and will only continue to sag more in the future.

With the clock and bell towers left considerably out of plumb, a decision must have been made to add framing to the north side of the belfry roof so as to make the upper stages and spire plumb, when they were put back on the tower. Today, those upper sections of the tower are still plumb, but unfortunately the lower stages are considerably out of plumb.

The arrow shows the framing added to the belfry roof in 1992 in order to make the upper sections of the tower plumb.

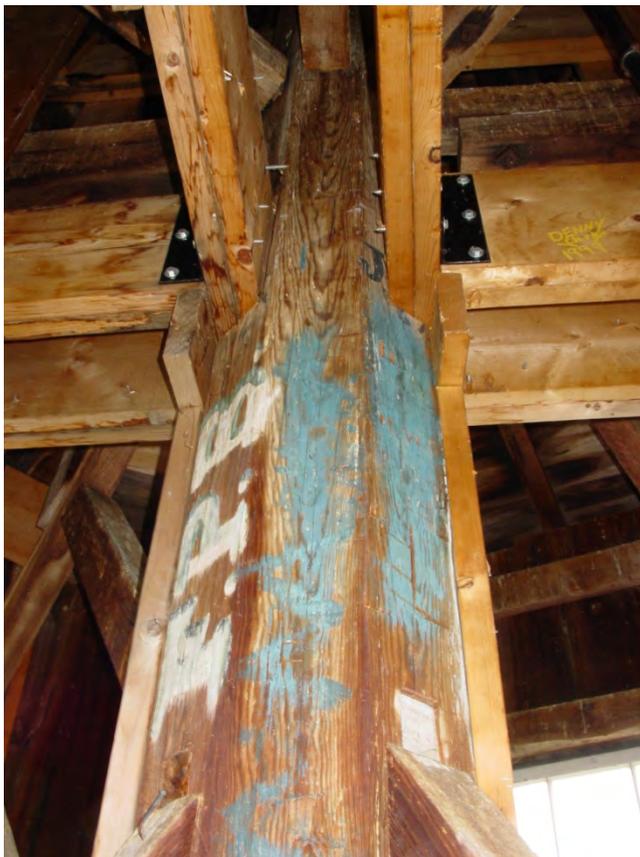
View showing the lower section of the spire, as it runs internally through the upper sections of the tower. All of the framing of these upper sections radiate out from this center pole. Note the additional framing added in 1992 (secured with metal corner brackets).

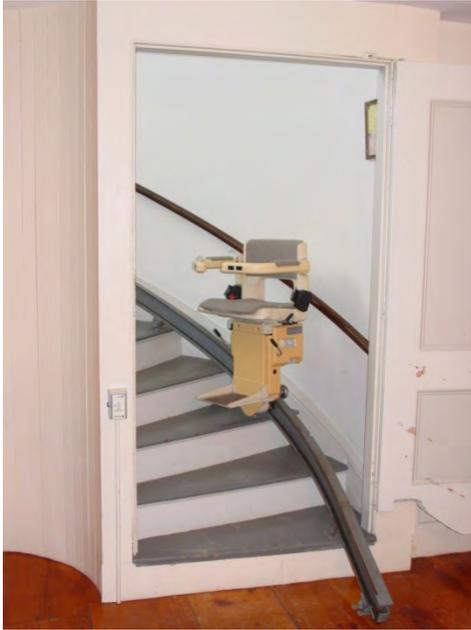
While the town and church have made major—and very sensitive—improvements to create an accessible entrance to the building, movement within the building is still not ideal. Once inside, an older-style, single-seat, winding chair lift provides access to the second floor church sanctuary. While the lift is serviceable, it does not meet current ADA requirements, nor is it comfortable for all. There is no ADA access to the former Town Hall in the rear of the ground floor of the Meetinghouse.

The chair lift brings people from the vestibule to the church sanctuary

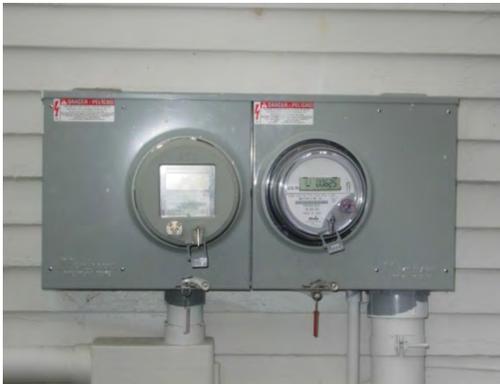
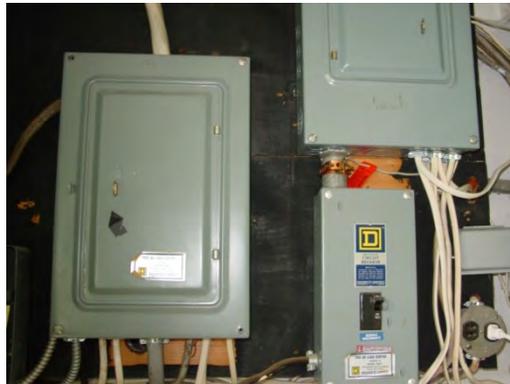
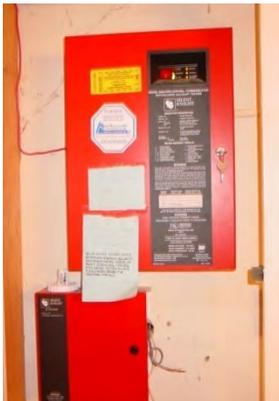
#### ***14. Electrical and Alarm Systems***

The electrical system is a 200 amp service with sub panels that is in working order and has been updated from time to time. There is still some older cloth wiring and some older style BX wiring that remains in use. The underground feed for the electrical service comes into the building from the east wall, near the south end.

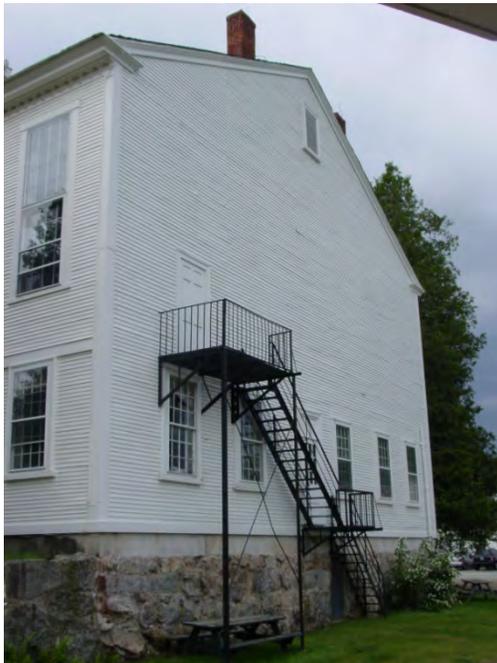
#### **8. ADA Access**

Since there is currently no ADA access to the former Town Hall and access to the second floor is minimal, it would make sense to consider achieving and improving access to these areas. The approach that could achieve both and be sensitive to the architecture of the Meetinghouse would be to add an elevator tower/stairway to the rear of the building in the area of, and replacing the outdated fire escape. The rear of the building is the least visible and most altered elevation. If such an approach is followed, it would be optimal to retain evidence of the former window patterns from the 1820 building as much as possible.

This solution would also provide better access to the cellar door, which is now partially covered by the fire escape. Also, there would be ample parking in close proximity to the tower, thus minimizing the distance from a vehicle to the door.
